**PW8 Pickup Header**  
**Auger: Right Bearing Hardware Upgrade (MD #147810)**  
**INSTALLATION INSTRUCTIONS**

This kit is intended to correct a problem on some 2015 model year PW8 pickup headers where the hardware securing the right side of the auger to the bearing block becomes loose during operation.

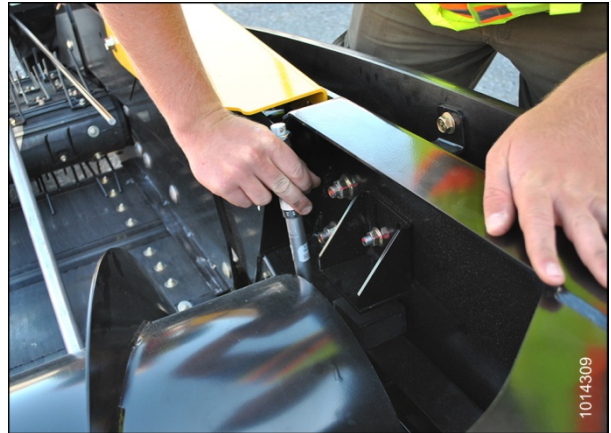
Figure 1: Accessing the Right Side of the Auger

1. Lower the pickup header to the ground, shut down the combine, and remove the key.
2. Access the existing bearing hardware from the right-hand side of the header—between the auger and the endshield.
3. Rotate the auger for the best access to the flange nuts that secure the auger bearing block to the auger.

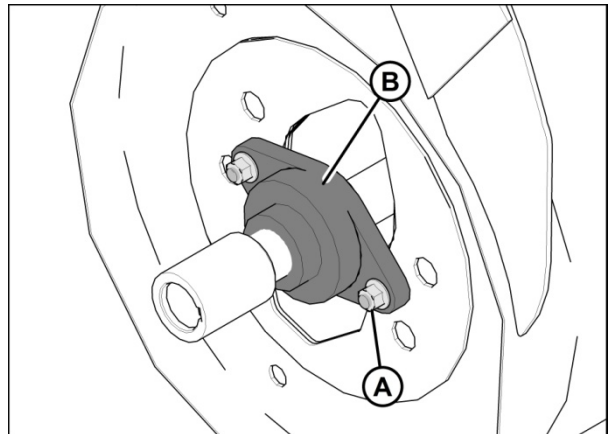
Figure 2: Right Auger Bearing

4. Remove an existing flange nut (A) from the bearing block (B).

**NOTE:** To maintain the alignment of the auger and the bearing block while removing the first nut, torque the other flange nut to 40–42 ft·lbf (54–57 N·m).

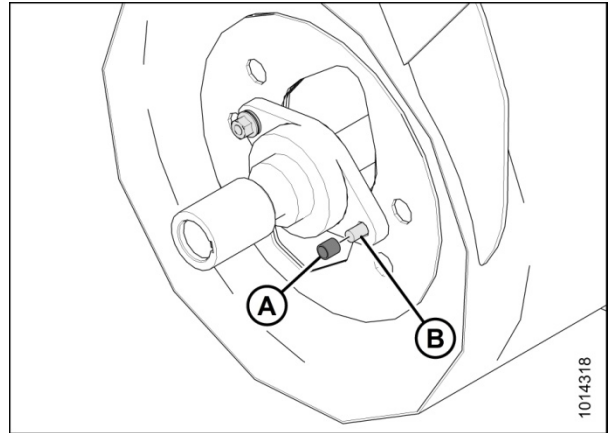
Figure 3: Right Auger Bearing

5. Place the new spacer (A) over the existing 35 mm carriage bolt and push it into the space between the bolt and the bearing block.

Be careful not to push the carriage bolt inside the auger. If ANY tools or hardware fall inside the auger, they MUST be removed before operating the pickup header.

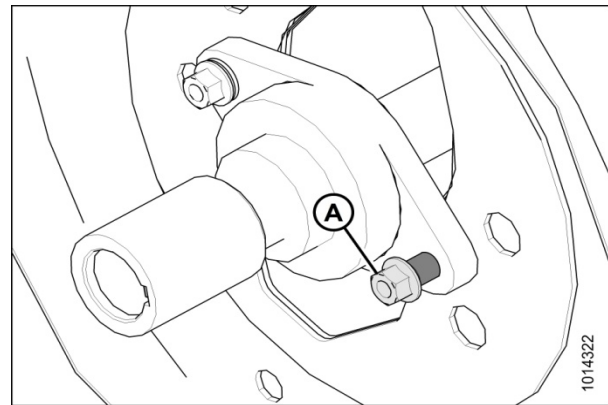
Figure 4: Right Auger Bearing: Installing the Spacer

6. If the spacer will not press into the bearing block, follow these steps:
  - a. Reach inside the auger to hold the carriage bolt in place.
  - b. Thread the old flange nut (A) onto the bolt (without the washer) and carefully tighten the nut to press the spacer into place.

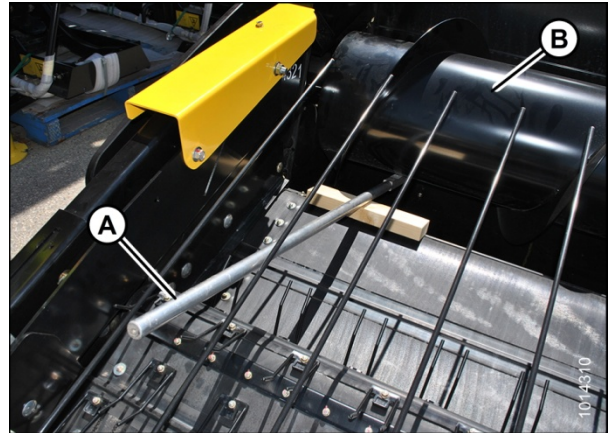
Figure 5: Pry Bar Supporting Auger

7. If necessary, take the weight off the bearing block using a pry bar (A) and a block of wood to support the auger (B) on the right side.

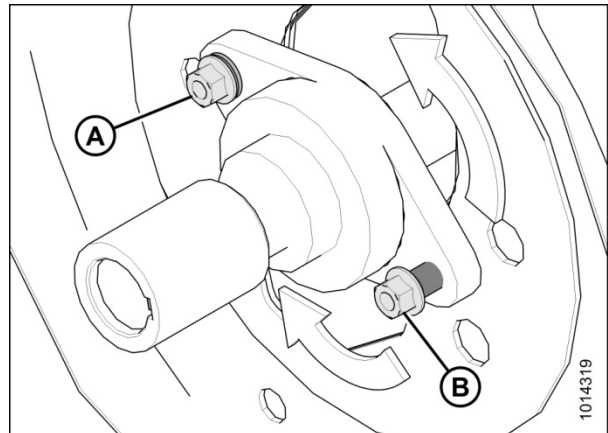
Figure 6: Right Auger Bearing: Adjusting the Position

8. If the spacer still won't fit (because the bolt is not centered in the bearing block) adjust the position of the bearing block as follows:
  - a. Loosen the second flange nut (A) to allow the bearing block to move slightly, and adjust the bearing until the spacer fits into the bolt hole.
  - b. When the spacer is seated inside the hole, tighten the old flange nut (B) to press the spacer into place.
9. Retighten the second nut (A).
10. Remove the old flange nut and discard.

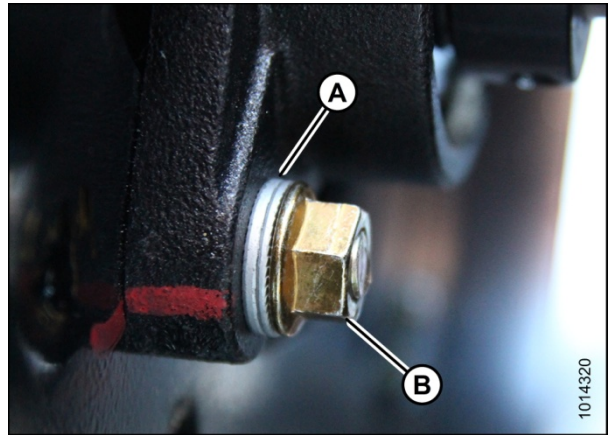
Figure 7: Right Auger Bearing: Nordlock Washer Installed

11. Install the new Nordlock washer (A) (supplied in the kit) with the flat/thicker side against the bearing block.
12. Install the new flange nut (B) (supplied in the kit) and torque to 40–42 ft·lbf (54–57 N·m).

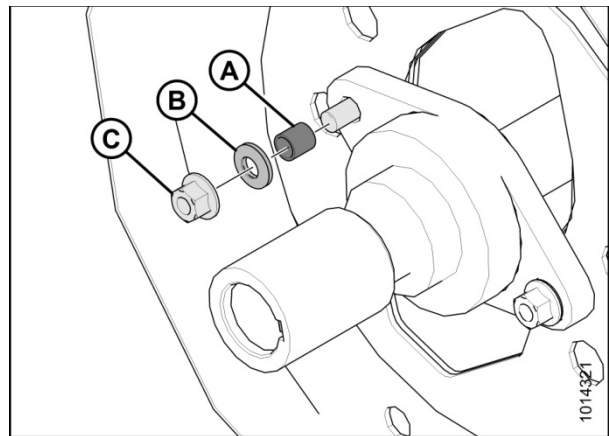
Figure 8: Right Auger Bearing: Second Bolt

13. Repeat the procedure to install the new spacer, Nordlock washer, and flange nut onto the second bolt.

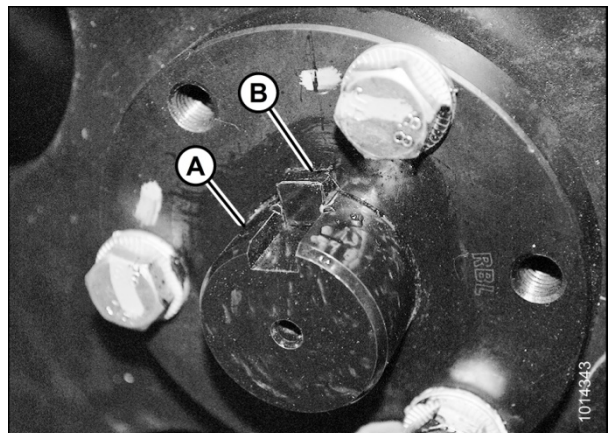
Figure 9: Left Auger Shaft Keyway

14. Open the left endshield.
15. Inspect the left end of auger to ensure that shaft (A) is sufficiently staked (deformed) to prevent the key (B) from sliding out.
16. If not, deform the shaft material at keyway with a punch and hammer.

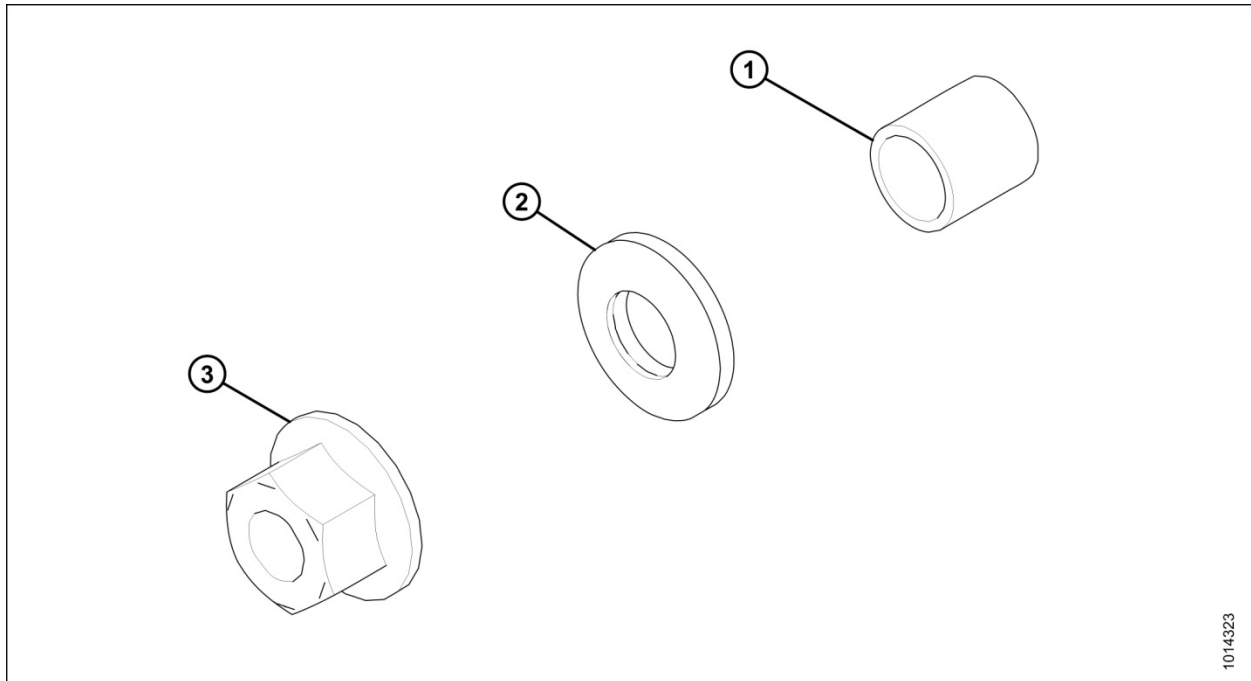
Figure 10: Parts Include in the Kit

This kit includes the following parts:
